# Manhole Inspection Summary

Manhole # S43EE\_066MH

Insp Date: **9/8/09 1:26 PM**

**Location** Address: **1050 BROADWAY**

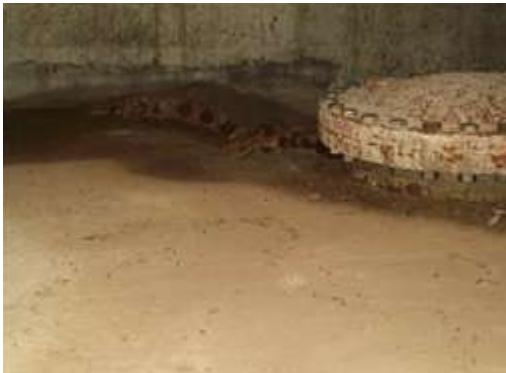
Top View

Comments **FORCE MAIN VAULT MH IS UNSAFE TO DIVE**
